**Flood Control Project Maintenance
Levee Inspections**
LMA District Cover Sheet
Spring 2020 Levee Inspection Results

Reclamation District No. 2075 McMullin

Spring 2020 Levee Inspection Results

Waterway			Bank	Unit Miles
Unit No. 01 San Joaquin River			Right	7.45
	Spring (March - May)	Summer (June - August)	(September - November) Fall	Winter (December - February)
Unit Maintenance Rating (Fall Only)				
Date of Inspection	3/25/2020 - 3/25/2020			
DWR Inspector	Alberto De Leon			
Accompanied By	Ed Cardoza

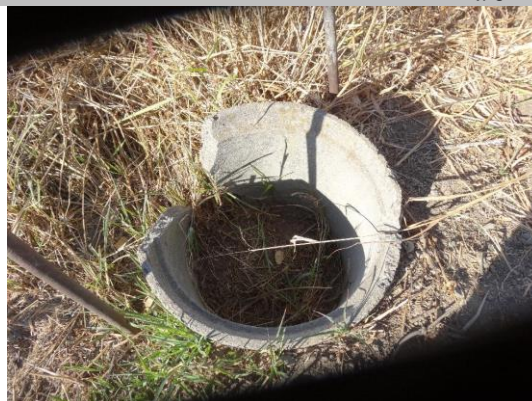
Photo 2 of 3 : UCIP_SP_2020_24663_44021.jpg

WS view: concrete pipe riser with siphon breaker on levee slope.

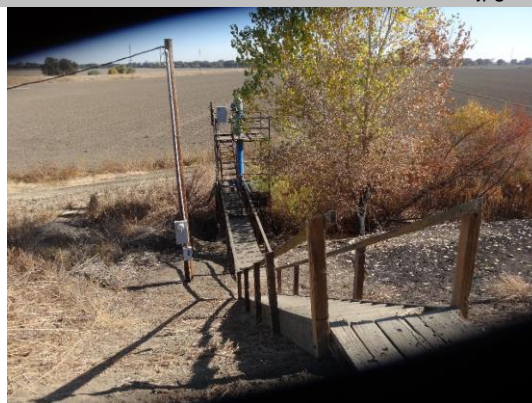
Photo 3 of 3 : UCIP_SP_2020_24663_44020.jpg

LS view: walkway, pump, service pole, and intake structure.

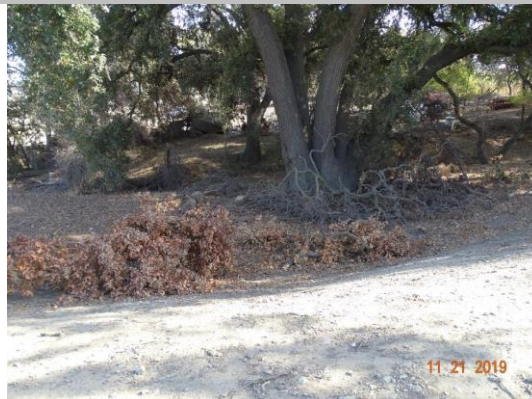
Photo 1 of 1 : SP_2020_RD2075_315_30_20200228_00039.jpg

LM Start	0.98	Rating **	M	Issue No.	30
LM End	0.98	Issue Type +	En	Location *	LS
Category	Earthen Levee			GPS Latitude/Longitude	
				Start	End
Item	Encroachments			37.740139 °	37.740139 °
				-121.281304 °	-121.281304 °
DWR ID	DWR_RD2075_01_s_ 2019_30				
Comment Code					
PR : Prunings					
Inspector Comment

View of prunings on landside slope. Fall 2019

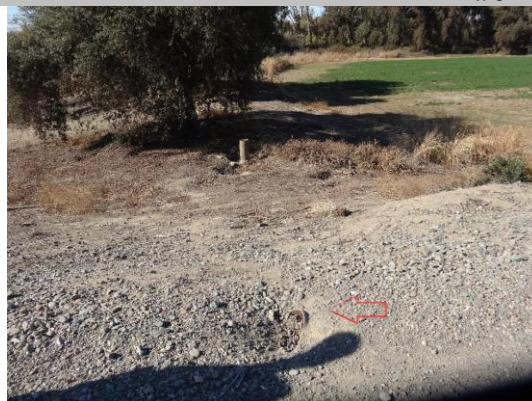
Photo 1 of 3 : UCIP_SP_2020_24666_45600.jpg

Comment Code						
Inspector Comment						
DS_ID:24737						
FS_ID:24666						
EP_NO: N/A						
Repair Type: Non-Urgent						
Crossing Status: Found						
UCIP Comments: - service pole on landside.- looks abandoned.						
Walkway in dilapidated condition.						
FIELD_STRUCT_DESC: 16-inch steel drainage discharge pipe through the levee, 4.5 feet below the crown. Corrugated metal cutoff wall. Pump mounted on a pile structure in a drainage ditch on the landside (LS).						
Siphon breaker in a corrugated metal pipe (CMP) riser on the waterside (WS) slope. [Additional Reference(s): DWR Levee Log, 2005. USACE San Joaquin O&M Manual 3, December 1968, (HLM 2.30)].						
FS Date: 11/13/2013

WS view: concrete standpipe (top) and steel pipe riser (bottom marked) on levee slope.

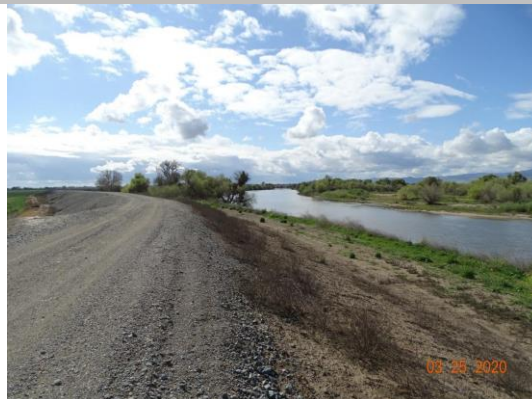
Photo 1 of 2 : SP_2020_RD2075_315_16_20200327_00064.jpg

Slope protection repairs are needed along the waterside slope due to erosion. Based upon levee inspections, it was determined the waterside levee slopes were eroding, deteriorating and degrading in concave pocket sections at various locations along this levee reach. The eroded levee sections need to be restored back to design standards to prevent further deterioration of the damaged levee sections. Low priority because of the wide berm. Could not see all of the bank because of vegetation. Rock was placed on LS here during this years (2017) storms

View of waterside slope looking upstream. Spring 2020

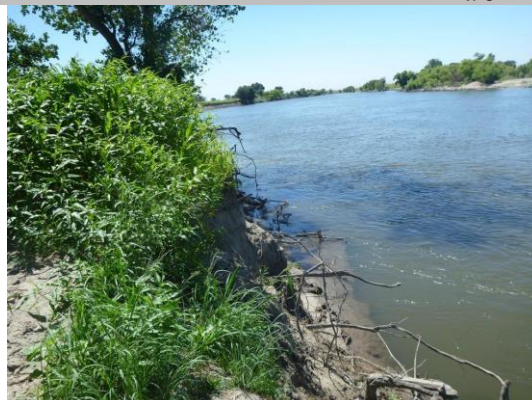
Photo 2 of 2 : LEVAL_SP_2020_480_2209.jpg

View of erosion on channel bank.

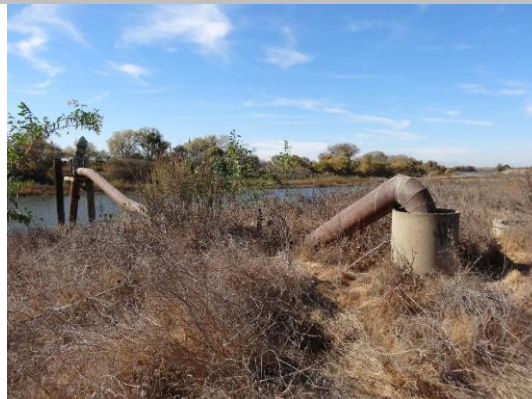
Photo 1 of 3 : UCIP_SP_2020_41721_45982.jpg

Comment Code						
Inspector Comment						
DS_ID:24746						
FS_ID:41721						
EP_NO: N/A						
Repair Type: Non-Urgent						
Crossing Status: Found						
UCIP Comments: Several concrete structure with Alfalfa valve. Only steel pipe visible on river bank. Service pole on waterside.New field discovered crossing.						
FIELD_STRUCT_DESC: 10-inch polyvinyl chloride (PVC) irrigation discharge pipe through the levee, at an unknown depth. Slant pump on the riverbank. Distribution box on the waterside (WS) berm. Concrete U-shaped headwall and open outlet on the landside (LS) toe. Crossing was field discovered. (Plans to install a slant pump on the riverbank authorized under Permit No. 5484, 1966 - Jack Clinton).						
FS Date: 11/13/2013

WS view: slant pump and concrete distribution box on levee berm.

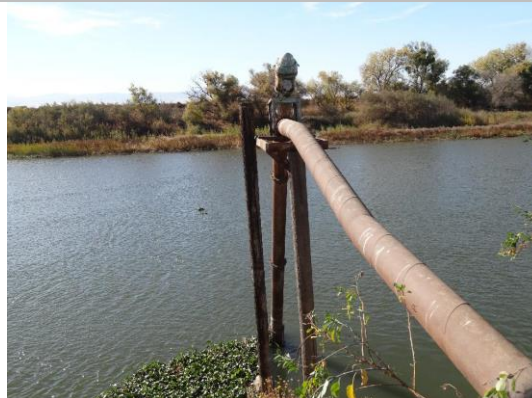
Photo 2 of 3 : UCIP_SP_2020_41721_45981.jpg

WS view: slant pump on timber pile in the stream.

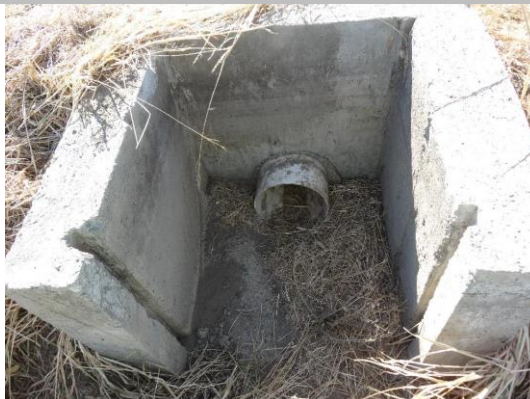
Photo 3 of 3 : UCIP_SP_2020_41721_45980.jpg

LS view: concrete U type headwall on levee toe and open PVC pipe.

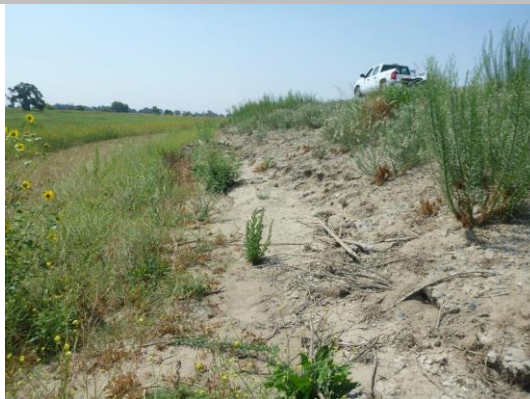
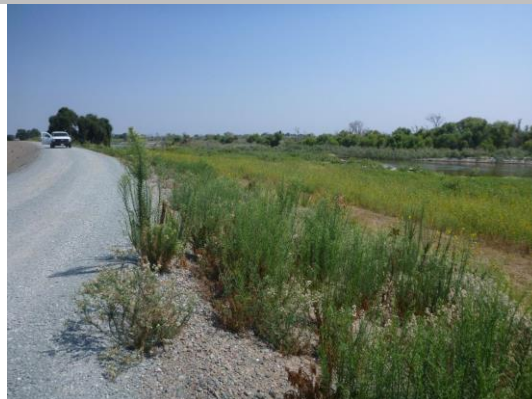
Slope protection repairs are needed along the waterside slope due to erosion and riprap displacement from high water. Based upon levee inspections, it was determined the waterside levee slope is eroding, deteriorating, and degrading. The eroded levee sections need to be restored back to design standards to prevent further deterioration and damage.

Site ID No: 576 & 577, Site Designation: LMA-482 & LMA-483

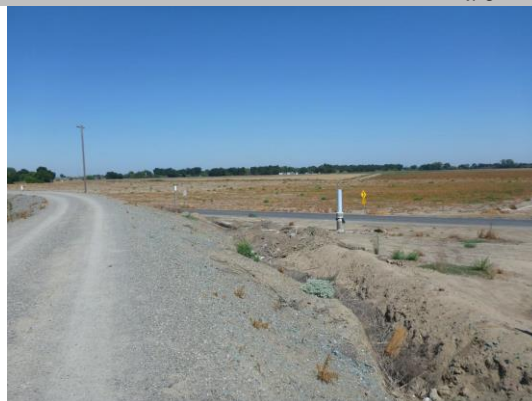
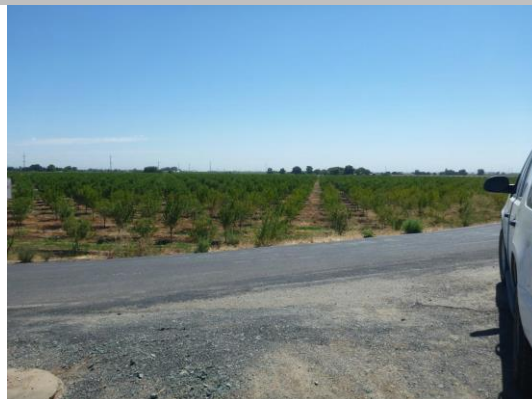
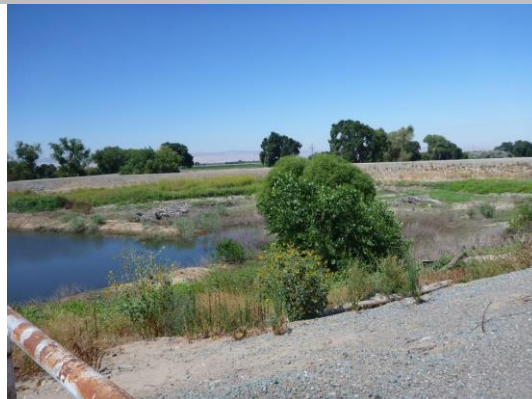
LM Start	4.95	Rating **	A/W	Issue No.	20
LM End	5.20	Issue Type +	Ob	Location *	LS
Category	Earthen Levee			GPS Latitude/Longitude	
				Start	End
Item	Seepage / Sandboils			37.727200 °	37.728900 °
				-121.277800 °	-121.275200 °
DWR ID	LMA-308				
Comment Code					
Inspector Comment					
Heavy seepage was observed during the high water this year 2017. Site ID No:481, Site Designation:LMA-308

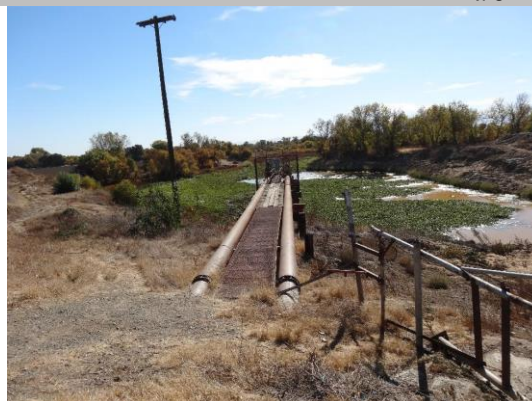
Photo 1 of 3 : UCIP_SP_2020_50209_45603.jpg

DS_ID:24739
 FS_ID:50209
 EP_NO: N/A
 Repair Type: Non-Urgent
 Crossing Status: Found
 UCIP Comments: - flap gates in concrete box on LS toe have failed and are open. Rusty through flapgate may indicate condition of interior of pipe.
 FIELD_STRUCT_DESC: 1 of 2: 16-inch steel irrigation discharge pipe through the levee, 8 feet below the crown. Electrical conduit through the levee. Pump mounted on a pile structure in the river. Wooden walkway to the pump. Siphon breaker and concrete distribution box on the landside (LS) slope. [Additional Reference(s): DWR Levee Log, 2005, 18-inch pipe referenced. USACE San Joaquin O&M Manual 3, December 1968, (HLM 5.16), 18-inch pipe referenced].
 FS Date: 6/21/2016

WS view: two pipes, walkway to pump and pile structure in the stream.

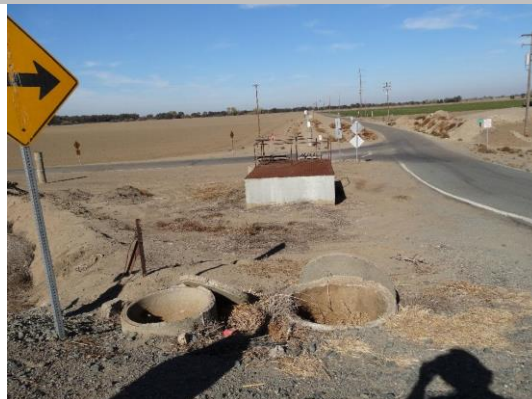
Photo 2 of 3 : UCIP_SP_2020_50209_45602.jpg

LS view: siphon breakers in concrete pipe risers (bottom) on levee slope. Concrete distribution box on levee toe (top).

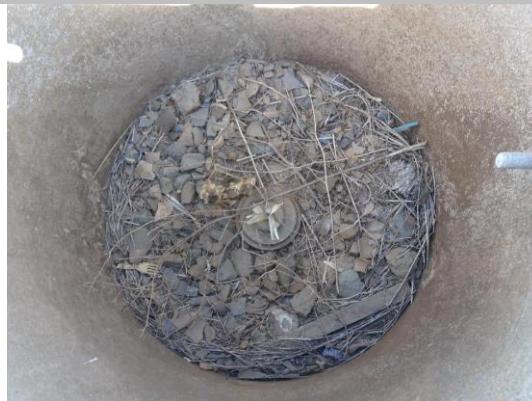
Photo 3 of 3 : UCIP_SP_2020_50209_45605.jpg

LS view: siphon breaker in concrete pipe riser on levee slope.

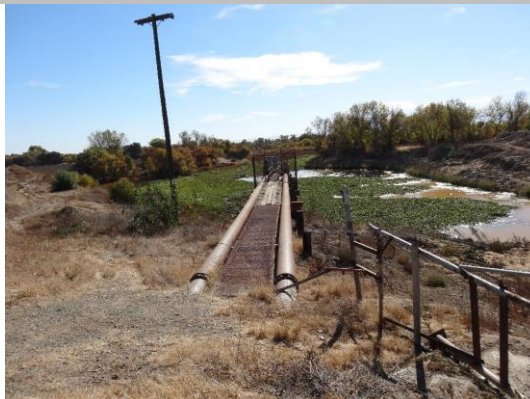
Photo 1 of 3 : UCIP_SP_2020_25184_45608.jpg

LM Start	5.20	Rating **	M	Issue No.	53	
LM End	5.20	Issue Type +	En	Location *		
Category	Supplemental			GPS Latitude/Longitude		
				Start		End
Item	DWR UCIP Field Study			37.728848 °	37.728848 °	
				-121.275195 °	-121.275195 °	
DWR ID	24743					
Comment Code						
Inspector Comment						
DS_ID:24743 FS_ID:25184 EP_NO: N/A Repair Type: Non-Urgent Crossing Status: Found UCIP Comments: Flap gate lid displaced. FIELD_STRUCT_DESC: 2 of 2: 16-inch steel irrigation discharge pipe through the levee, 8 feet below the crown. Electrical conduit through the levee. Pump mounted on a pile structure in the river. Wooden walkway to the pump. Siphon breaker and concrete distribution box on the landside (LS) slope. [Additional Reference(s): DWR Levee Log, 2005, 18-inch pipe referenced. USACE San Joaquin O&M Manual 3, December 1968, (HLM 5.16), 18-inch pipe referenced]. FS Date: 11/13/2013

WS view: two pipes, walkway to pump and pile structure in the stream.

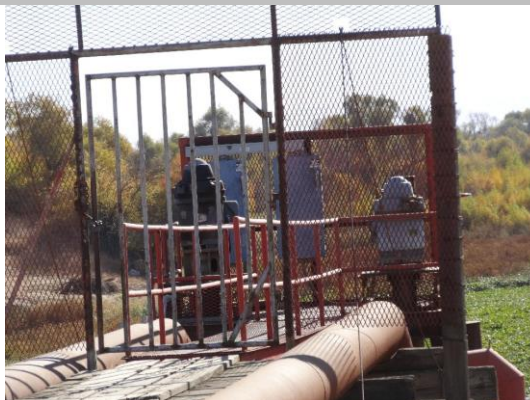
Photo 2 of 3 : UCIP_SP_2020_25184_45607.jpg

WS view: closer view of two pumps and platform in the stream.

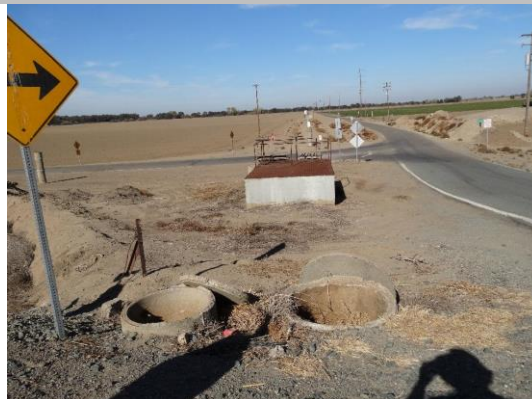
Photo 3 of 3 : UCIP_SP_2020_25184_45606.jpg

LS view: siphon breakers in concrete pipe risers (bottom) on levee slope. Concrete distribution box on levee toe (top).

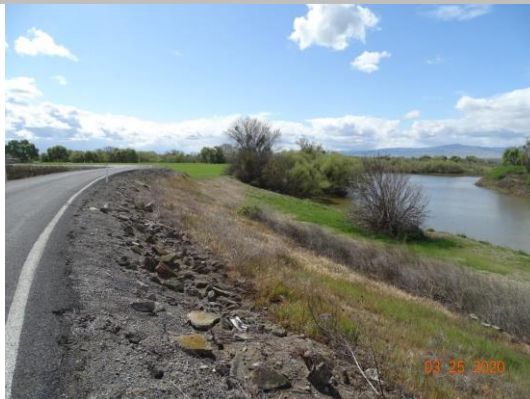
Photo 1 of 2 : SP_2020_RD2075_315_23_20200402_00065.jpg

LM Start	5.24	Rating **	A/W	Issue No.	23
LM End	5.29	Issue Type +	Ma	Location *	WS
Category	Earthen Levee			GPS Latitude/Longitude	
				Start	End
Item	Erosion / Bank Caving			37.728460 °	37.727799 °
				-121.274670 °	-121.274250 °
DWR ID	LMA-33				
Comment Code					
E1 : Note and monitor erosion site.					
Inspector Comment					
Slope protection repairs are needed along the waterside slope due to erosion and riprap displacement from high water. Based upon levee inspections, it was determined the waterside levee slope is eroding, deteriorating, and degrading. The eroded levee sections need to be restored back to design standards to prevent further deterioration and damage. Site ID No: 578 & 79, Site Designation: LMA-484 & LMA-33

View of 2017 storm damage waterside erosion-area of concern. Spring 2020

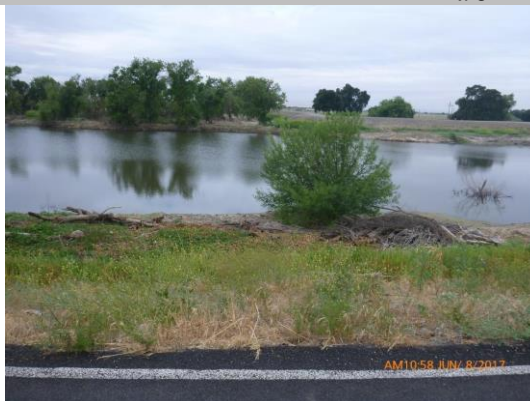
Photo 2 of 2 : LEVAL_SP_2020_79_1331.jpg

June 2017

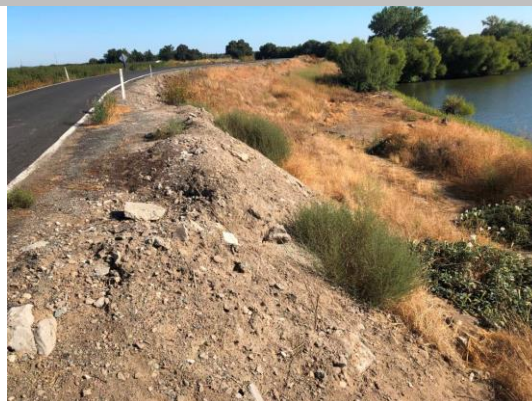
Photo 1 of 3 : SP_2020_RD2075_315_1_20200228_00001.jpg

Site ID: RD2075U01RM64.34
 09/17/2019: No significant change observed.
 09/13/2017: No significant change observed.
 07/12/2016: No significant change observed.
 08/28/2015: No significant change observed. Loose material is visible at the upper levee slope. The loose soil may have been caused by runoff.
 08/18/2014: No significant change observed.
 09/10/2013: No significant change observed.
 09/13/2012: No significant change observed.
 08/18/2011: No significant change observed. Some new material added to the water side levee slope, but the added material is loose and seems not helping the levee protection.
 10/05/2010: No significant change observed. Levee slope has minimal vegetation and lacks rip rap protection. Sandy material found on the lower and middle slope is an undesirable material to have on a levee.
 08/05/2010: Recommended for annual assessment and monitoring during flood events, per CLRO.

08/20/2009: No major change since last visit; site is located in an oxbow; slope surface consists of very sandy material; there is a tree on site leaning and with exposed tree roots; site is recommended as a local maintenance issue, per CLRO CES Evaluation 2008 Report; Eddy Cordoza from the district is aware of the site and is looking for recommendation; site is previously rated "U".
 08/17/2007: Site is close to an irrigation pump inlet.

Upstream view of the erosion site.

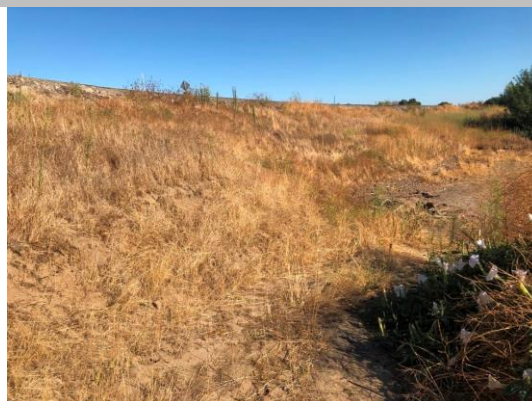
Photo 2 of 3 : SP_2020_RD2075_315_1_20200228_00002.jpg

Close-up view of the site.

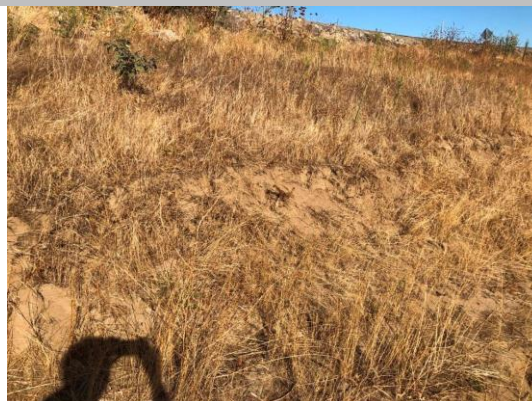
Photo 3 of 3 : SP_2020_RD2075_315_1_20200228_00003.jpg

Looking at the eroded levee slope.

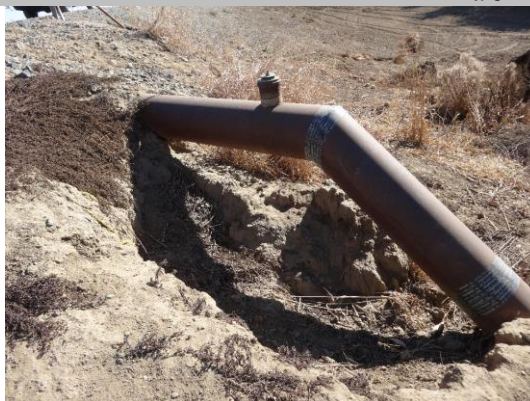
Photo 1 of 3 : UCIP_SP_2020_50191_44262.jpg

DS_ID:24740
FS_ID:50191
EP_NO: 3492
Repair Type: Non-Urgent
Crossing Status: Found
UCIP Comments: 06/21/2016 Rock revetment placed along WS slope beneath and around pipe; this corrected the levee erosion but still unclear whether the cause of the erosion was addressed. I found no evidence of siphon breaker leakage cited previously. Eddy Cardoza of RD2075 mentioned he saw no leak in and around pipe when the levee slope was repaired. Crossing was been downgraded from Urgent to Non-Urgent. (K. Fazel - UCIP)11/13/2013 Huge erosion on waterside levee slope due to siphon breaker leakage. It is not 16-inch but 12-inch steel pipe. Pump not mounted on pile structure but mounted on concrete sump. Siphon breaker not in concrete riser but on steel pipe. Pipe is not 8 ft. below the crown but 4 ft below the crown. Looks original pipe was replaced with new crossing. Needs more information from LMA or DWR Inspector. (P. Amatya - DWR)

FIELD_STRUCT_DESC: 12-inch asphalt coated steel drainage discharge pipe through the levee, 4 feet below the crown. Concrete cutoff wall. Pump mounted on a concrete sump in a drainage ditch approximately 200 feet off the landside (LS) toe. Siphon breaker on the apex of the pipe through the waterside (WS) slope. (Plans to replace the discharge pipe across the levee authorized under Permit No. 3492, 1960 - Reclamation District No. 2075, care of Eldred E. Brown, Secretary. Plans to replace a 10-horsepower pump and a 10-inch pipe with a larger 15-horsepower pump and a 14-inch steel discharge pipe authorized under Permit No. 3492-A, 1969 - Reclamation District No. 2075, care of Eldred E. Brown, Secretary). [Additional Reference(s): DWR Levee Log, 2005, 16-inch pipe referenced. USACE San Joaquin O&M Manual 3, December 1968, (HLM 5.52), 16-inch pipe referenced].
FS Date: 6/21/2016

WS view: siphon breaker on steel pipe on levee slope. Huge soil erosion due to siphon breaker leakage.

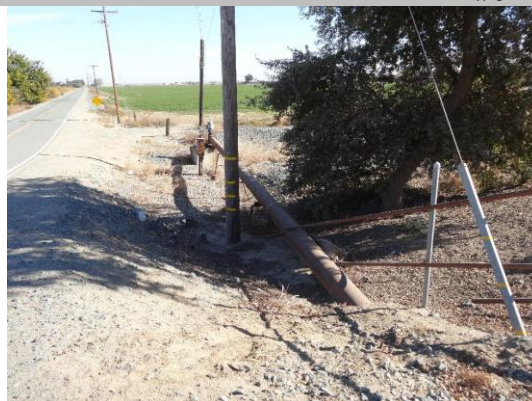
Photo 2 of 3 : UCIP_SP_2020_50191_44261.jpg

LS view: pipe, pump and concrete sump in the drain ditch.

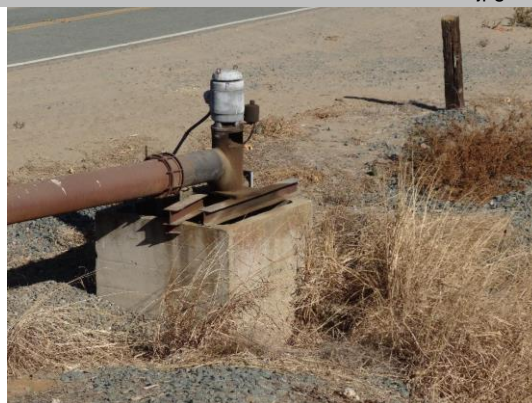
Photo 3 of 3 : UCIP_SP_2020_50191_44260.jpg

LS view: closer view of pipe, pump and concrete sump in the drain ditch.

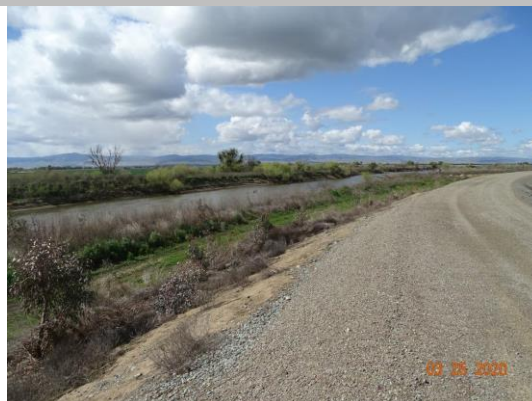
Photo 1 of 2 : SP_2020_RD2075_315_28_20200402_00067.jpg

LM Start	5.87	Rating **	A/W	Issue No.	28
LM End	6.33	Issue Type +	Ma	Location *	WS
Category	Earthen Levee			GPS Latitude/Longitude	
				Start	End
Item	Erosion / Bank Caving			37.721710 °	37.720960 °
				-121.267490 °	-121.259830 °
DWR ID	LMA-485				
Comment Code					
E1 : Note and monitor erosion site.					
Inspector Comment					
Slope protection repairs are needed along the waterside slope due to erosion and riprap displacement from high water. Based upon levee inspections, it was determined the waterside levee slope is eroding, deteriorating, and degrading. The eroded levee sections need to be restored back to design standards to prevent further deterioration and damage. Site ID No: 579 & 580, Site Designation: LMA-485 & LMA-486

View of waterside slope looking downstream. Spring 2020

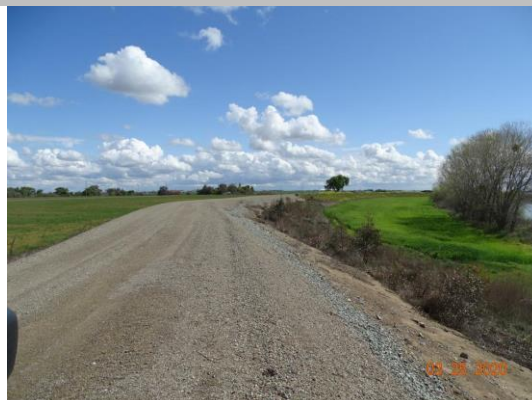
Photo 2 of 2 : SP_2020_RD2075_315_28_20200402_00068.jpg

View of waterside slope looking upstream. Spring 2020

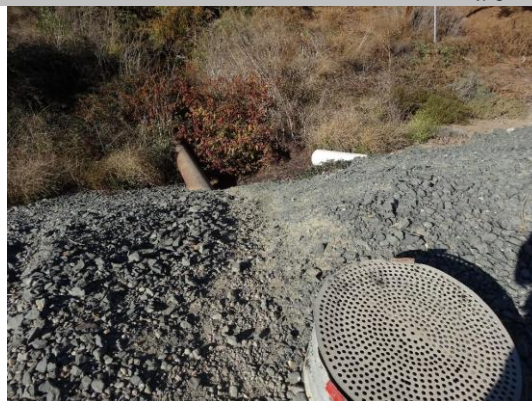
Photo 1 of 3 : UCIP_SP_2020_50213_45613.jpg

Comment Code					
Inspector Comment					
DS_ID:24742 FS_ID:50213 EP_NO: 4051 Repair Type: Non-Urgent Crossing Status: Found UCIP Comments: 06/21/2016: Erosion repaired with rock revetment and crown regraded. Pipe is crushed and deformed on LS. PVC pipe has been removed. Crossing has been downgraded from Urgent to Non-Urgent.11/13/2013:- exposed deformed pipe on landside slope. Soil erosion also occurred around the deformed pipe. Walkway at pump on LS toe in poor structural condition.- a temporary 12-inch PVC pipe also found on both sides of the levee. FIELD_STRUCT_DESC: 12-inch steel drainage discharge pipe through the levee, 5.5 feet below the crown. Corrugated metal cutoff wall. Pump mounted over a concrete sump at the landside (LS) toe. Siphon breaker in a corrugated metal pipe (CMP) riser on the waterside (WS) shoulder. Ditch across the WS berm. 12-inch polyvinyl chloride (PVC) pipe through the levee, 1 foot below the crown, installed for emergency use during the 1986 floods, not found in 2016. (Plans for installation of a 10-inch drainage discharge pipe for a drainage pump over the levee authorized under Permit No. 4051, 1962 - Reclamation District No. 2075). [Additional Reference(s): DWR Levee Log, 2005, 10-inch pipe referenced. USACE San Joaquin O&M Manual 3, December 1968, (HLM 6.79), 10-inch pipe referenced]. FS Date: 6/21/2016

WS view: CMP riser (bottom) on levee shoulder. Steel pipe (top) and temporary pvc pipe on levee slope.

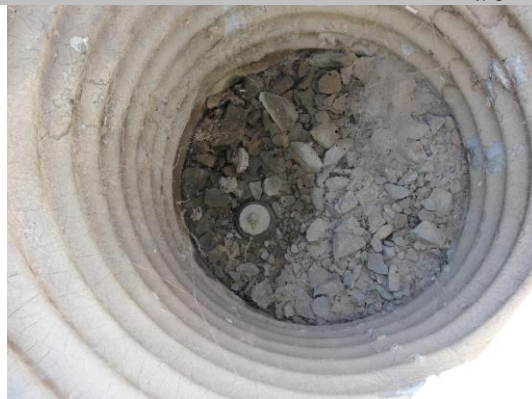
Photo 2 of 3 : UCIP_SP_2020_50213_45612.jpg

WS view: siphon breaker in CMP riser on levee shoulder.

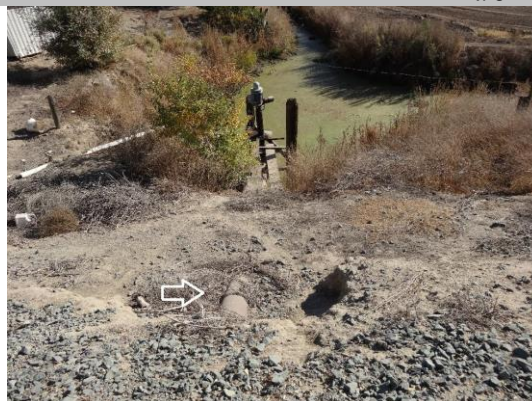
Photo 3 of 3 : UCIP_SP_2020_50213_45614.jpg

LS view: deformed pipe and soil erosion around it (marked bottom). Pipe and pump on pile structure in drain ditch.
